FLIGHT MEASUREMENTS OF THE FLYING QUALITIES

OF AN F6F-3 AIRPLANE (BUAER NO. 04776)

III - STALLING CHARACTERISTICS

MR. No.-L5B13b

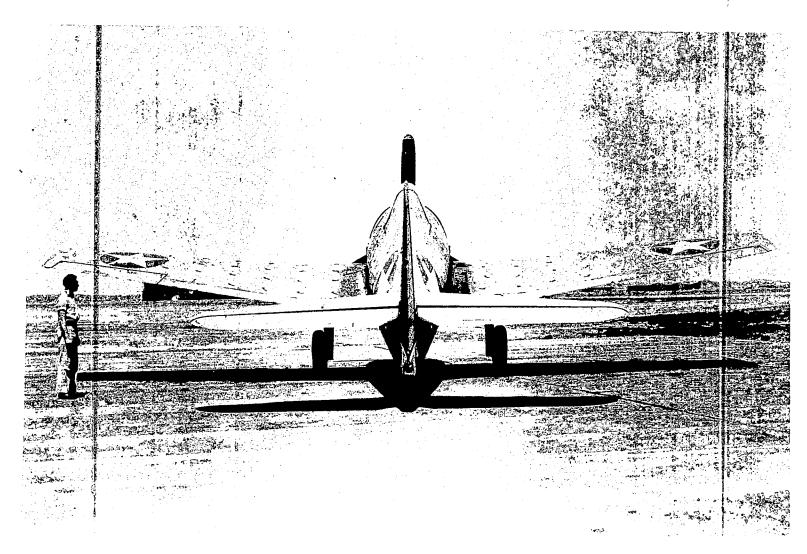
Figure 1.- Rear view of the F6F-3 airplane.

General views of the F6F-3 airplane are shown in figures 1 and 2. Figure 3 is a three-view layout of the subject airplane. Pertinent details and dimensions of the F6F-3 are given in reference 1.

The stalling characteristics of the F6F-3 airplane in steady flight were determined in stalls made by gradually decreasing the speed in straight flight. The motions of the airplane and of the controls were recorded during the stall approach and in some cases after the stall. The stability characteristics and the maximum lift coefficients during the stall approaches were determined. A camera had been installed in the airplane in order to check the rate of roll during low-speed aileron rolls. The camera installation was then used to make some tuft studies of the left wing. These tuft studies are rather limited and no particular effort was made to obtain a complete series of tuft pictures. Figure 1 shows the tufts on the wing.

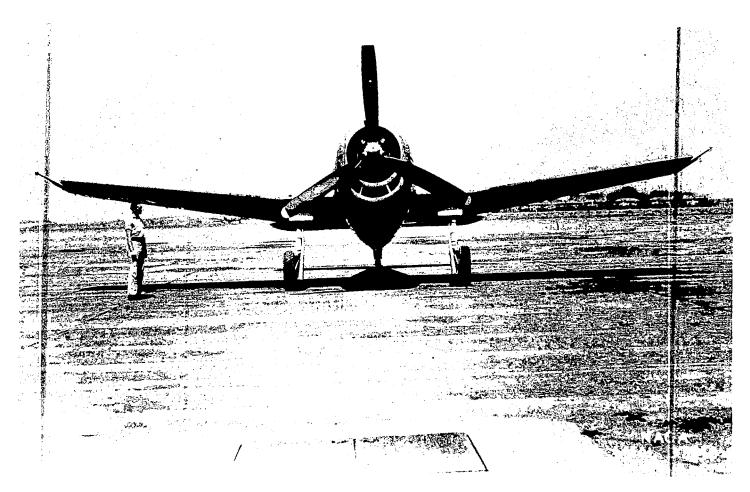
Figure 2.- Front view of the F6F-3 airplane.

- (a) In the gliding condition (figs. 4 and 5) stall warning was afforded by a howl in the duct on the underside of the engine cowling (see fig. 2) beginning about 18 miles per hour above the stall and by an increased general vibration of the airplane felt in the stick and rudder pedals about 5 miles per hour above the stall. In addition, there was a very mild buffeting beginning 1 to 2 miles per hour above the stall and increasing in intensity as the initial roll off to the left occurred. This buffeting preceding the roll-off cannot be relied upon as a stall warning since it was obtained only with very slow approaches to the stall: In the stall, where the pilot attempted to hold the rudder and ailerons fixed after the initial roll-off (fig. 4), a rolling and mild pitching oscillation set in which increased in amplitude until the complete stall. Tuft pictures of the left wing taken during this run (fig. 14) show that the wing alternately stalled and unstalled during the oscillation. Use of the rudder and ailerons after the initial roll-off (fig. 5) resulted in diminished motion of the airplane up to the final stall. Maximum lift coefficient in the gliding condition varied from 1.35 to 1.45.

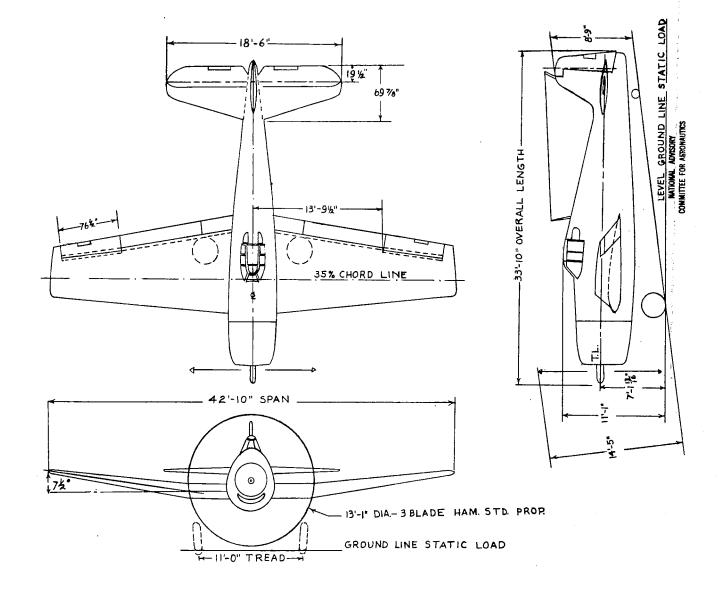
Figure 3. - Three-view layout of the F6F-3 airplane.

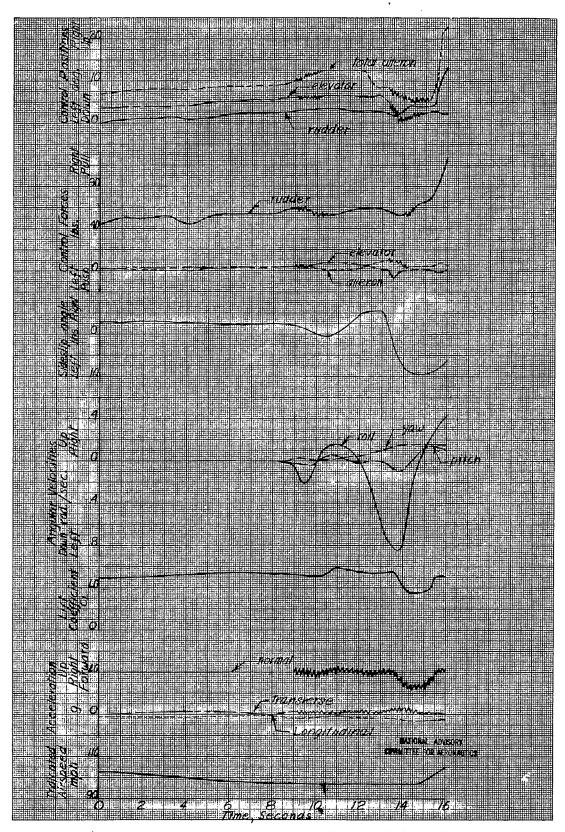
Figure 4. - Time history of a stall in gliding condition in which the pilot attempted to hold the alleron and rudder controls fixed after the initial roll-off. F6F-3 airplane.

Time histories of stall approaches in the various conditions of flight are given in figures 4 to 13. Tuft studies corresponding to figures 4 and 12 are given in figures 14 and 15. The stalling characteristics may be summarized as follows:

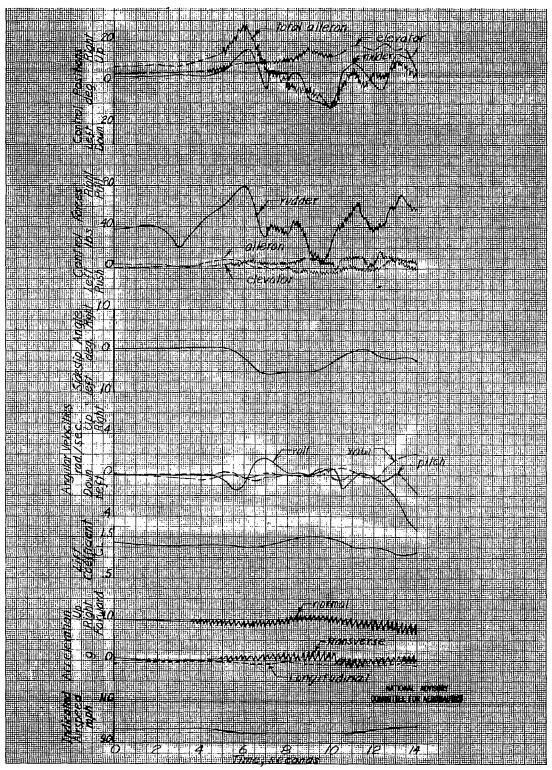
Figure 5. - Time history of a stall in the glicing condition in which the pilot attempted to control the airplane through the stall. FoF-3 airplane.

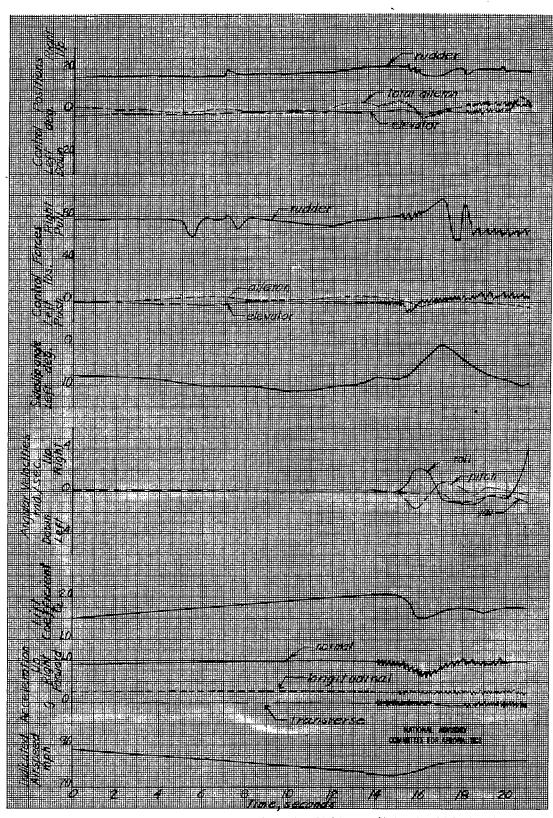
Figure 6. - Time history of a stall in the climbing condition in which the pilot attempted to hold the rudder and allerons fixed after the initial roll-off. F6F-3 airpl-ne.

- (b) In the climbing condition (figs. 6 and 7), general vibration of the airplane increased noticeably about 7 miles per hour above the stall. About 2 miles per hour above the stall a very mild buffeting set in. The intensity of this buffeting increased as roll-off to the right occurred. In the control-fixed stall (fig. 6), there was mild rolling and pitching up to the final roll-off. Use of the controls (fig. 7) resulted in rather violent motions of the airplane as the pilot overcontrolled. Maximum lift coefficient in the climbing condition varied from about 2.1 to 2.2.

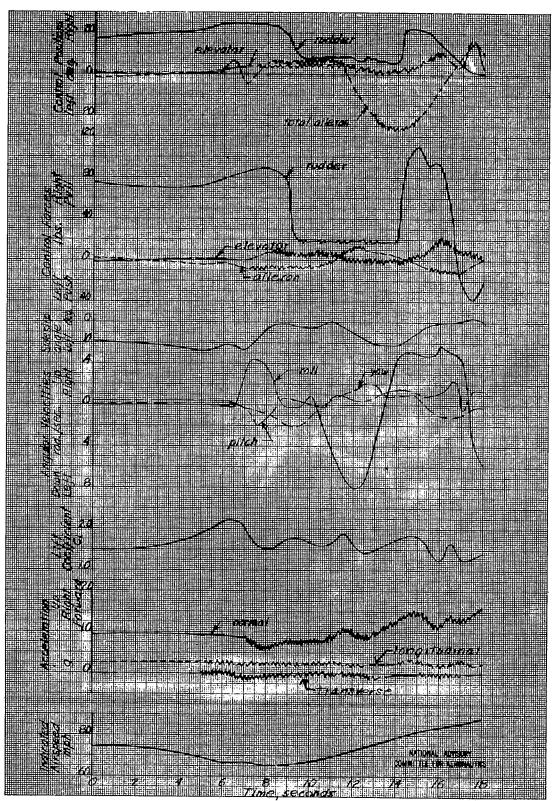
Figure 7. - Time history of a stall in the climing condition in which the pilot attempted to control the airplane through the stall. F6F-3 airplane.

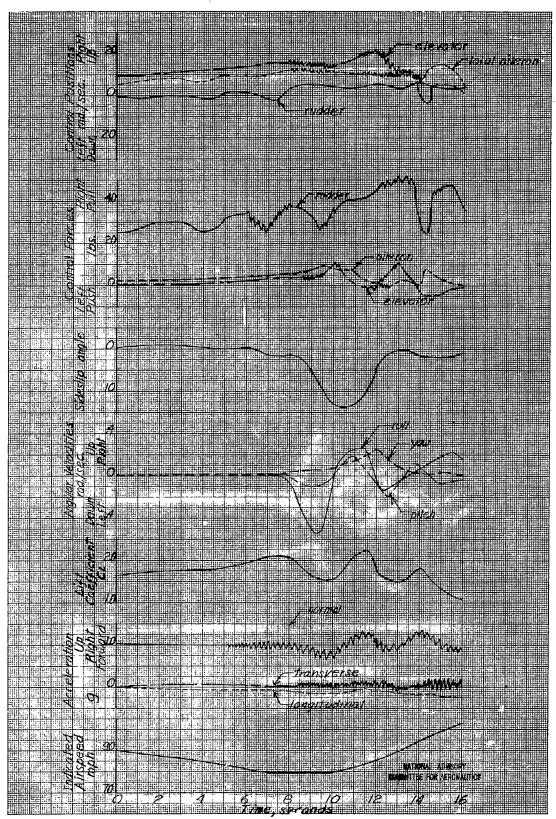
Figure 8. - Time history of a stall i the landing condition in which the pilot attempted to hold the rudger and allerons fixed after the initial roll-off. FoF-3 airplane.

- (c) In the landing condition (figs. 8 and 9), a duct howl preceded the stall as in the gliding condition and a very mild buffet set in 1 or 2 miles per hour above the stall. As in the gliding and climbing conditions the buffet preceding the stall is noticeable only in a very slow stall approach. The stick-fixed stability was high for this condition and the stick was well back at the stall. The initial roll-off in all cases was to the left. In the control-fixed stall (fig. 8) the initial roll-off was followed by a rolling and pitching oscillation. Figure 9 shows that the pilot in attempting to control the airplane through the stall overcontrolled

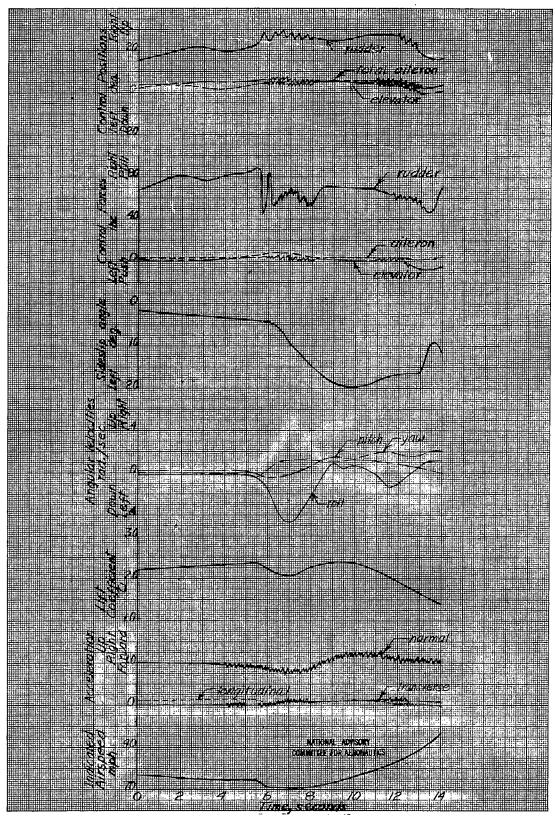
Figure 10. - Time history of a stall in the approach condition in which the pilot attempted to hold the rudder and alterons fixed after the initial roll-off. F6F-3 airplane.

- (d) In the approach condition (figs. 10 and 11) there was no stall warning. The initial roll-off was to the left. After the initial roll-off there was some buffeting of the airplane. A control-fixed stall is shown in figure 10. As shown in figure 11 the initial roll-off could be checked by use of the ailerons. Maximum lift coefficient in the approach condition varied from 2.35 to 2.45.

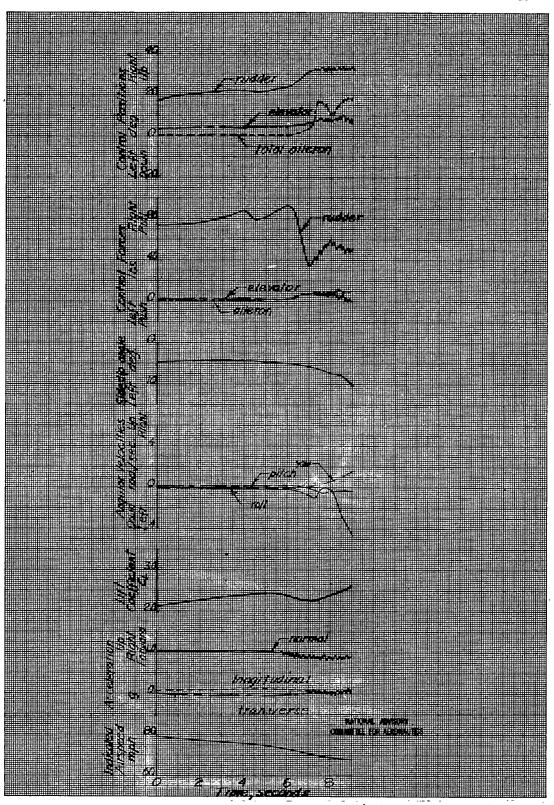
Figure 11. - Time history of a stall in the approach condition in which the pilot attempted to control the airplane through the stall. FoF-3 airplane.

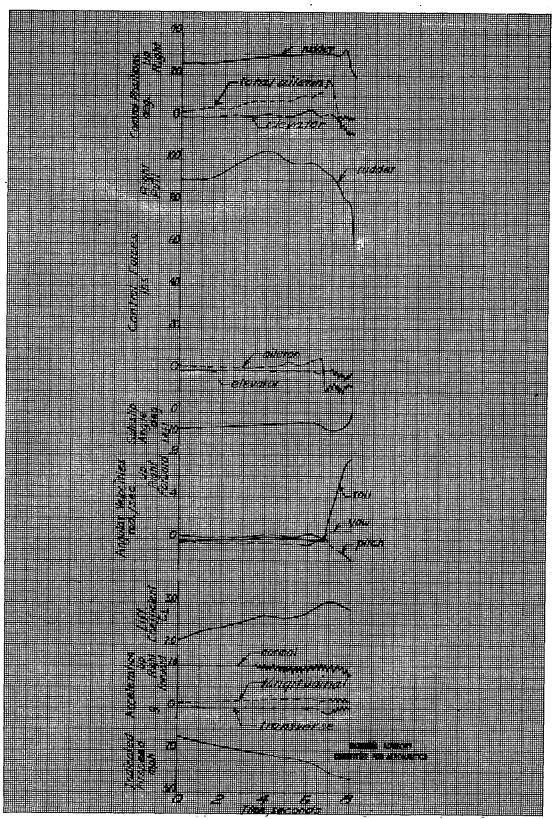
Figure 12. - Time history of a stall in the wave-off conditions. (Recording instruments were turned off after initial roll-off.) FoF-3 airplane.

- (e) In the wave-off condition (figs. 12 and 13), there was no stall warning whatsoever. The initial roll-off was to the right and was more severe than in any of the other conditions tested. This roll-off could be checked, however, by use of allerons and rudder as shown in figure 13. Tuft pictures of the left wing made during the run shown on figure 12 show in figure 15 that the stall begins at the root and progresses outward. It should be noted, however, that the airplane rolled to the right in this run; and, therefore, the stall will be more extensive than that shown in figure 15 for the left wing. Maximum lift coefficient was approximately 3.0 in the wave-off condition.

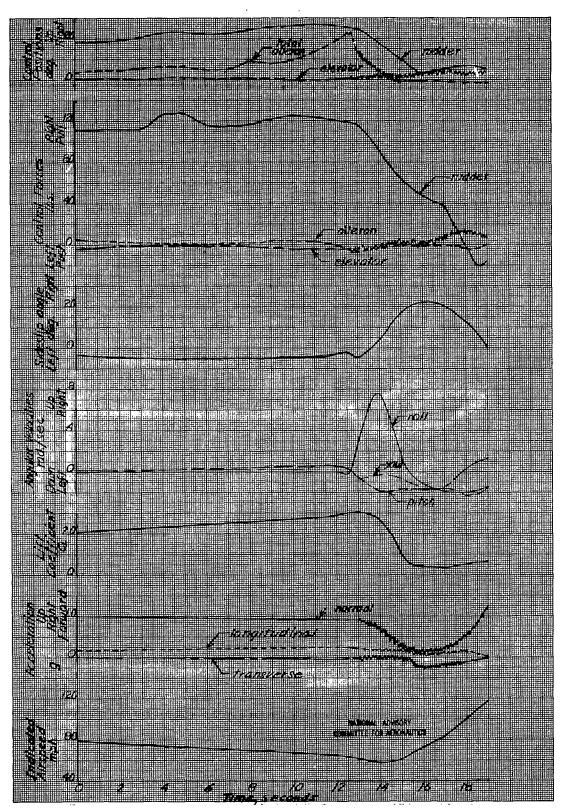
Figure 13. - Time history of a stall in the wave-off condition in which the pilot attempted to control the airplane through the stall. FoF-3 airplane.

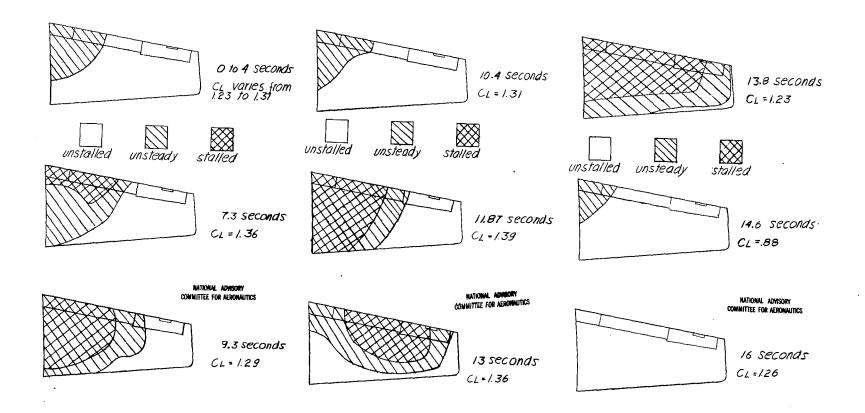
Figure 14.- Tuft studies of left wing during the stall in the gliding condition shown in figure 4. F6F-3 airplane.

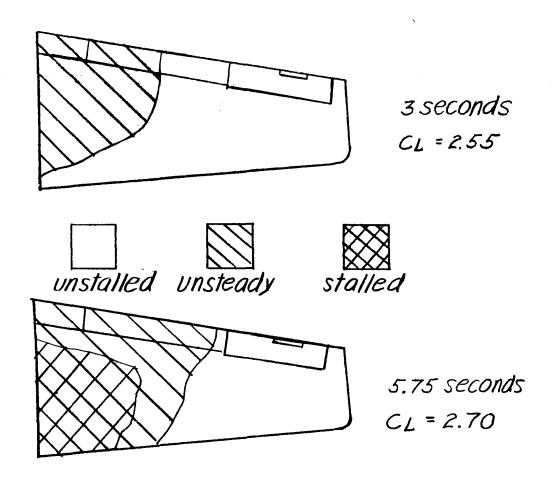
Figure 15.- Tuft studies of left wing during stall in wave-off condition shown in figure 12. F6F-3 airplane.
